# Field Performance and Wear Behavior of Atmospheric Plasma Spraying (APS) Coated Discs Used in Agricultural Disc Harrows

The wear performance of coated and uncoated harrow discs was evaluated under real agricultural field conditions in order to assess the long-term effectiveness of three atmospheric plasma spraying (APS) systems: a Cr<sub>2</sub>O<sub>3</sub>–SiO<sub>2</sub>–TiO<sub>2</sub> ceramic coating, a WC/W<sub>2</sub>C–Co carbide coating, and a Co–Cr–Ni–W–C alloy coating. In contrast to most previous studies focused on laboratory testing or short-term trials, the present work provides a comparative long-term field evaluation over 50 ha per disc (1000 ha total) under identical operating conditions in quartz-rich Argic Luvisol soil. Disc wear was quantified through periodic mass-loss and diameter measurements, complemented by microstructural and SEM analyses. The uncoated disc exhibited the most severe degradation, with a total mass loss of approximately 700 g and rapid acceleration of wear after the first 5–10 ha. The ceramic-coated disc showed the highest durability, limiting mass loss to approximately 390 g, corresponding to a reduction of about 44%, and maintaining the

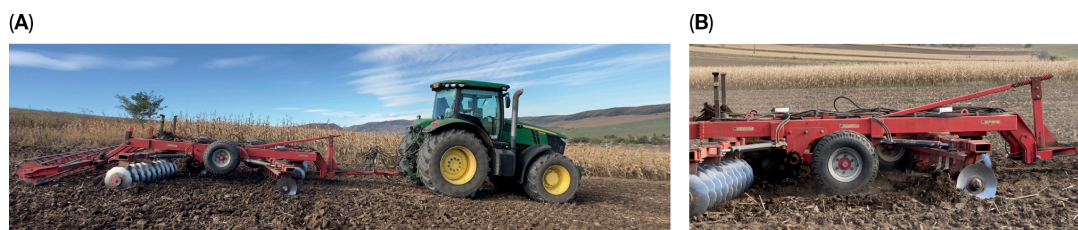
**Figure 6.** Disc harrow and tractor during field operation in stubble conditions. (A) Overview of the tractor and the 4 m disc harrow; (B) close-up side view with the implement in operation.

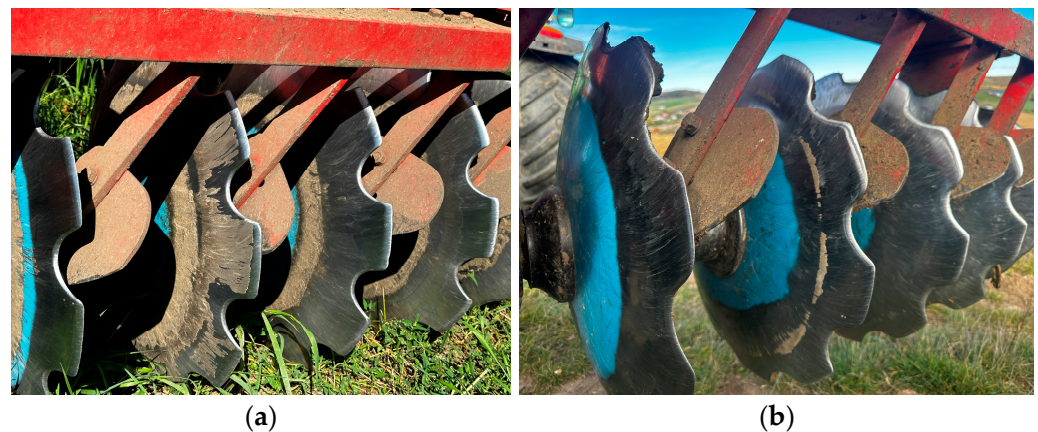
**Figure 12.** Field wear appearance of control sample, sample 1, sample 2, sample 3 from left to right. (a) After 25 ha per disc; (b) After 50 ha per disc.

After 50 ha per disc, the control disc displays pronounced edge rounding and surface abrasion, confirming its lower resistance to soil contact. Sample 1 continues to show the best preservation of edge geometry, with only moderate wear visible. The field appearance of the discs (Figure 12) confirms these trends.

Sample 1 demonstrates the best performance among all tested variants. The wear curve remains nearly flat over the first several hectares and even at 25 ha the mass reduction is limited to roughly 0.15 kg. Although wear accelerates slightly after this point, the total mass loss at 50 ha remains the lowest at approximately 0.39 kg. This behaviour indicates excellent long-term stability of the ceramic coating, particularly in abrasive quartz-rich soil.
