# Soil Conservation Measures on Degraded Land in the Hilly Region of Eastern Romania: A Case Study from Puriceni-Bahnari Catchment

**Citation:** Niacsu, L.; Bucur, D.; Ionita, I.; Codru, I.-C. Soil Conservation Measures on Degraded Land in the Hilly Region of Eastern Romania: A Case Study from Puriceni-Bahnari Catchment. *Water* **2022**, *14*, 525. <https://doi.org/10.3390/w14040525>

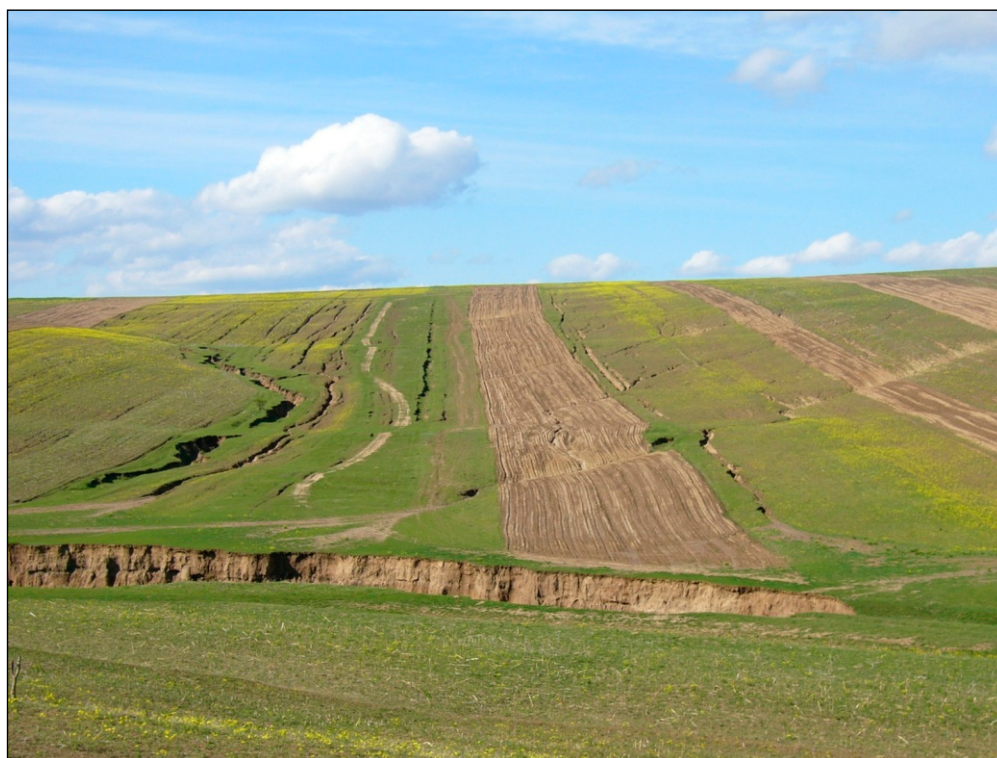
Over the last two hundred years, the destructive farming practices has prevailed, resulting in a high pressure on the landforms, soils and the vegetal cover [6]. Following the intense deforestation processes of the last two centuries and the expansion of agricultural areas, the erosion processes have manifested themselves more intensely on much larger areas [40] (Figure 5).

**Figure 5.** Intense land degradation by soil and gully erosion on the right side of Valcioaia Valley. (10 May 2005).

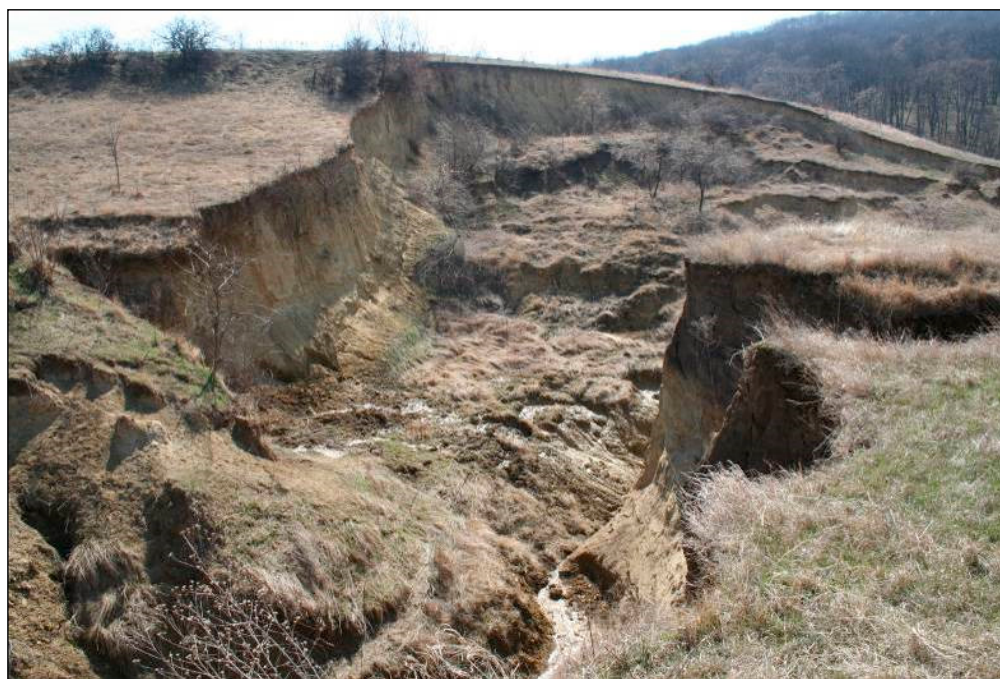
In the studied area, the main cause of the appearance of these huge landslides is exclusively related to the occurrence of gullies (Figure 9). This is due to the collapse of the base of the slopes as a result of the incision produced by the advance of continuous gullies.

**Figure 9.** Landslide caused by the extension of Valea Adanca gully, right tributary of the Puriceni-Bahnari Valley (March 2012).
